STRUCTURAL REPAIRS  
IN  
FORWARD AREAS  
DURING  
WORLD WAR II

December 1949

Bureau of Ships  
Navy Department

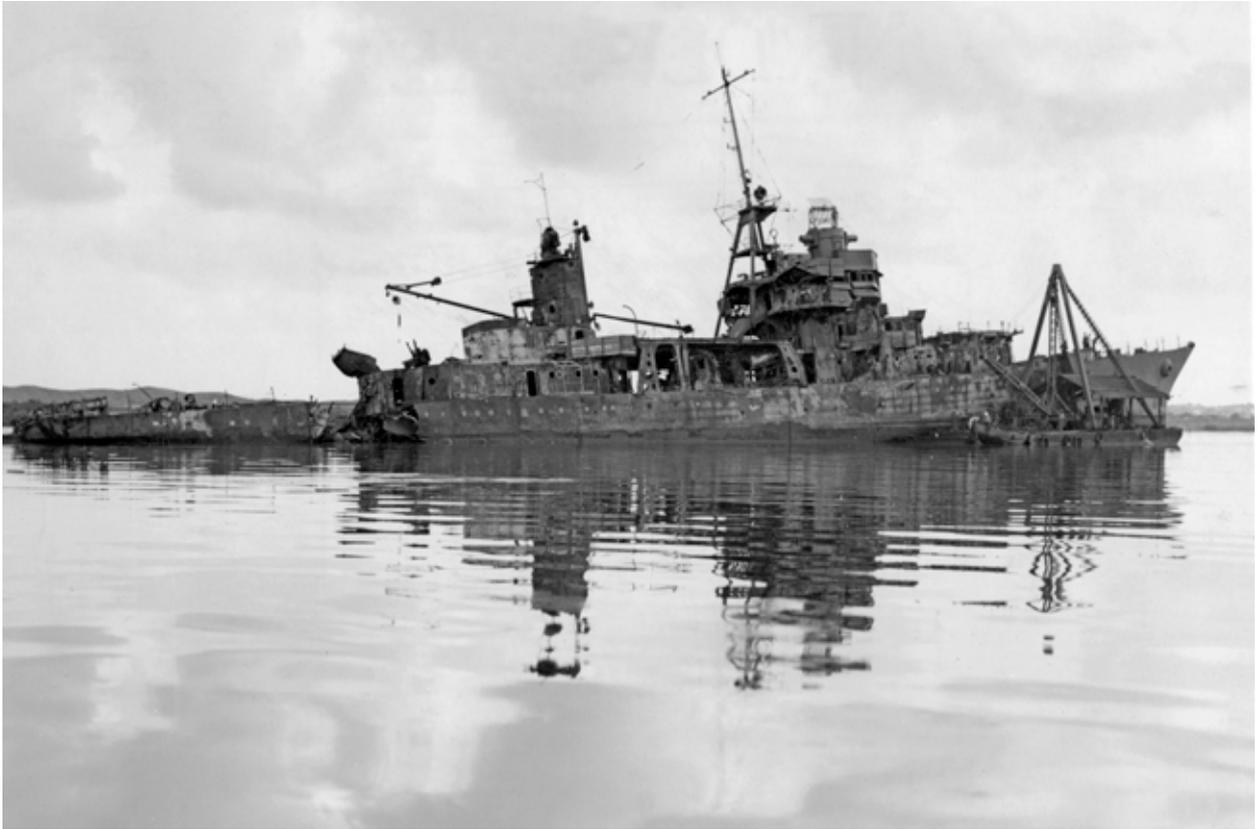
1. At 1733, 12 October 1942, a torpedo detonated about 5 feet below the waterline at frame 126, starboard (Plate 1, 2). The hull below the waterline was ruptured for a length of 45 feet. Transversely, the break extended from 5 feet to starboard of the keel up to the main deck and across the main deck almost to the port side (Photo 1). Fuel oil, diesel oil and gasoline tanks in way of the explosion were demolished, and the platform and second decks were ruptured. On the 2nd deck, bulkheads 119 and 131 were torn and the watertight door in bulkhead 107 was distorted and could not be closed. Oil and gasoline spread throughout the flooded 2nd deck compartments between bulkheads 99 and 141. This flooding represented about a 25% loss of waterplane area. A few seconds later a second explosion of considerable intensity occurred in the same area, probably the result of ignition of gasoline vapor. Fire, fed by gasoline and fuel oil, spread rapidly throughout the 2nd deck and through the after superstructure. Within 12 minutes, ready service ammunition for 6" mount 4 began to explode.

Photo 1: ERIE (PG 50) General view of torpedo and fire damage from off starboard quarter.

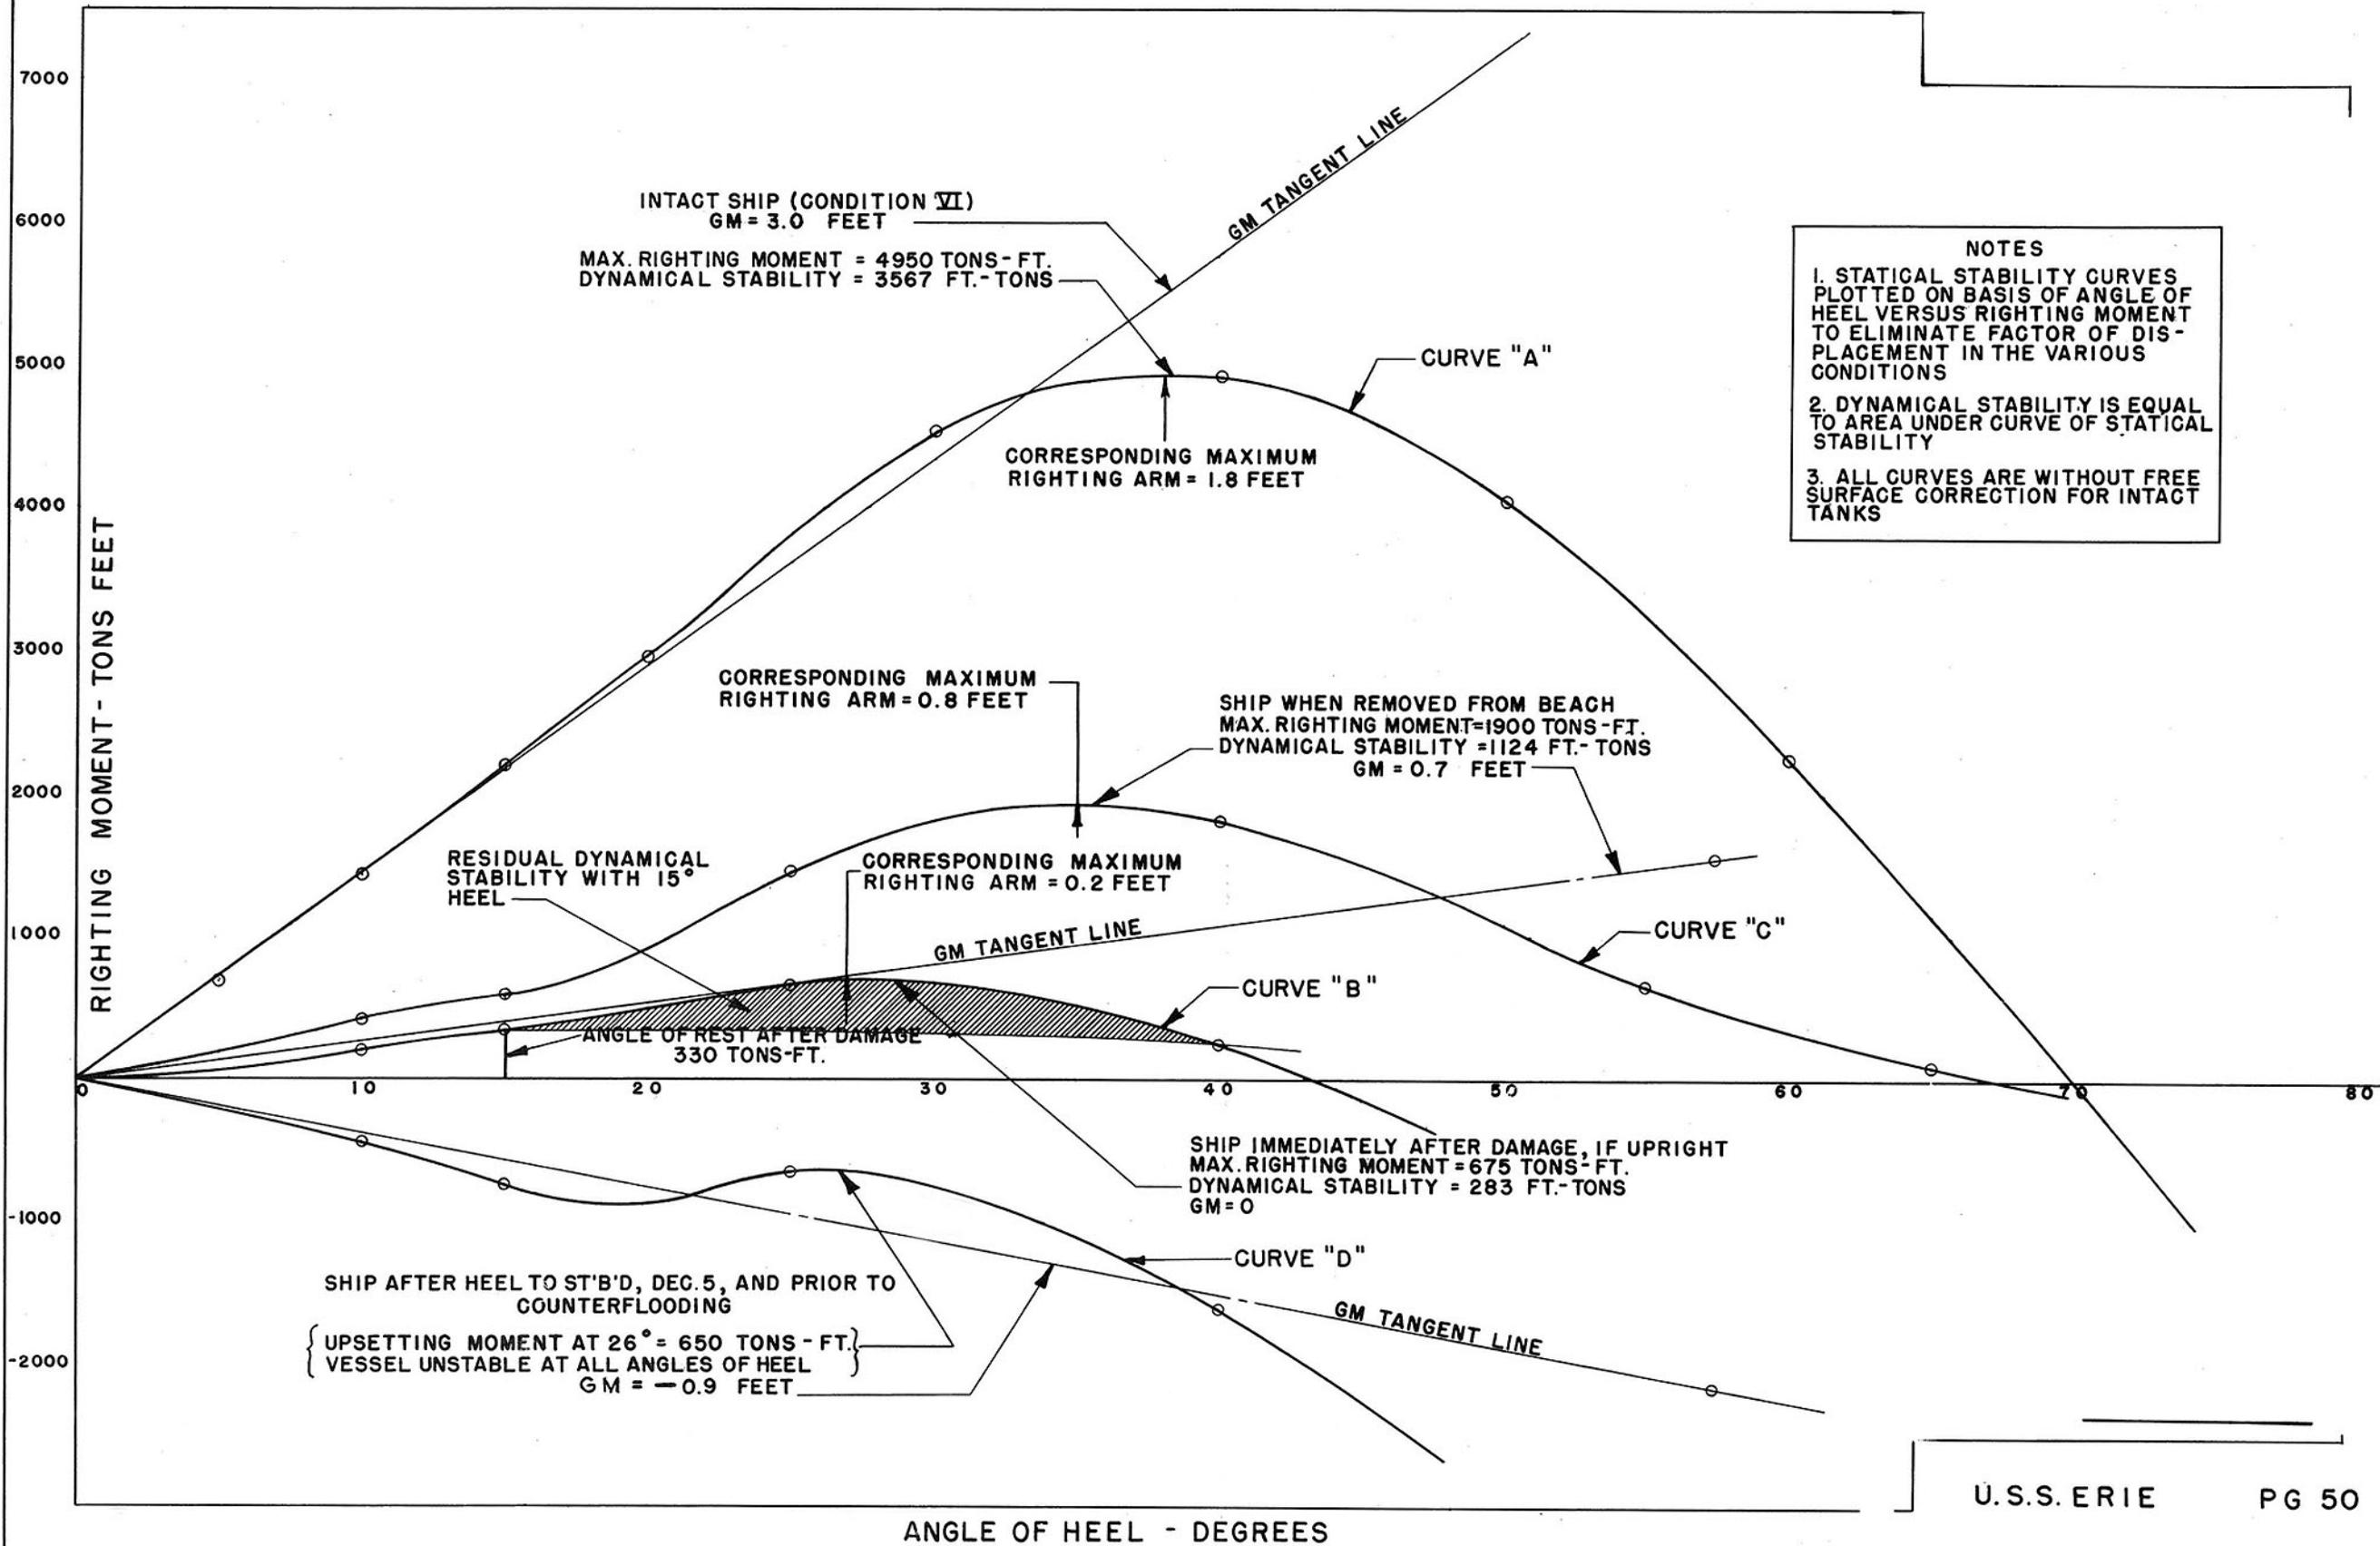
7. The best estimate of ERIE'S displacement before damage is 2730 tons, giving a corresponding draft of 14' 2". This corresponds closely with Condition VI of the inclining experiment data. Curve A of plate 3 is the curve of statical stability for this condition. GM, uncorrected for free surface, was about 3.0'. Although the distribution of liquids is uncertain, free surface correction could not have been greater than 3" and is omitted. ERIE was in a condition which offered the greatest resistance to underwater damage and also provided satisfactory stability characteristics.

The center of gravity was lowered only 0.4' and GM was increased only to 0.7'. Curve C of Plate 3 is the stability curve for this condition. At small angles, below about 15°, the effect of weight removal is not appreciable. The greatest effect was to increase the maximum righting moment to about 1900 tons-feet and to increase the range of stability nearly to the intact value. The total dynamic stability required for capsizing was increased to 1124 tons-feet, about 32% of the intact value. Although stability when ERIE was refloated was considerably better than it had been before beaching, ERIE was still in a critical condition. The 8 1/2° port list when ERIE was refloated could have been caused by unsymmetrical distribution of remaining weights. The flooding of the port shaft alley and the 20 tons remaining in A-4F and A-418F would have been sufficient to cause this list had ERIE been otherwise balanced.

12. The free surface effect, incident to the flooding on the 2nd deck, reduced GM by 1.6' to -0.9'. ERIE probably would have capsized to starboard had not the barge prevented. Counterflooding of A-4F and A-418F provided an ever increasing port moment. Curve D of Plate 3 is for D-1W flooded, free surface to the centerline of C-201L, and A-4F and A-418F empty. It is a close approximation of ERIE'S stability condition immediately before counter-flooding and capsizing. Since neither initial nor dynamic stability was positive, the only immediate action which could have saved ERIE was rapid removal of free surface in C-201L and cautious addition
