U.S.S. ERIE

December 9, 1942

Subject: Report of the Torpedoing, Fire and Beaching
of U.S.S. ERIE.

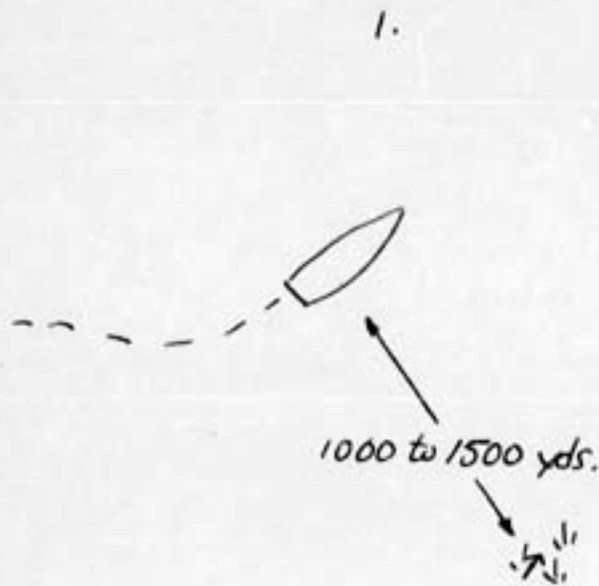
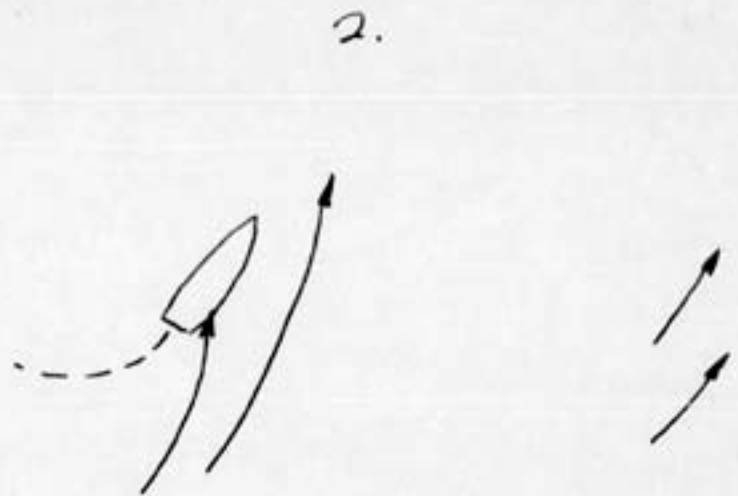
ENCLOSURE (A) DIAGRAM 2

1. The ship was patrolling station at about 14.7 knots speed in the sector about 4000 to 5000 yards ahead of the convoy. A break was noted in the surface of the water about 1000 to 1500 yards on the starboard beam. The Officer-of-the-Deck's estimate was 2000 yards. It appeared as though it might have been made by two fish moving approximately parallel to the ship, though the spray thrown up and the action in the water appeared more violent. It was commented that it might be the porpoising of two torpedoes, and if so there was a submarine inside the screen. The Commanding Officer gave the order to "come right" to investigate and started from the wing of the bridge to give orders regarding the shifting of the sound search to the direction of the possible submarine. Almost immediately the Navigator, Lieutenant Commander Roscoe, now further aft on the same wing of the bridge reported that there appeared to be a torpedo on the quarter (starboard) and advised coming left. At a glance it was evident that a second pair of torpedoes was approaching from the starboard quarter. The order for "hard left rudder" was given followed by the order "full speed." The Officer

1. Spray Sighted.
2. Torpedo Hit.

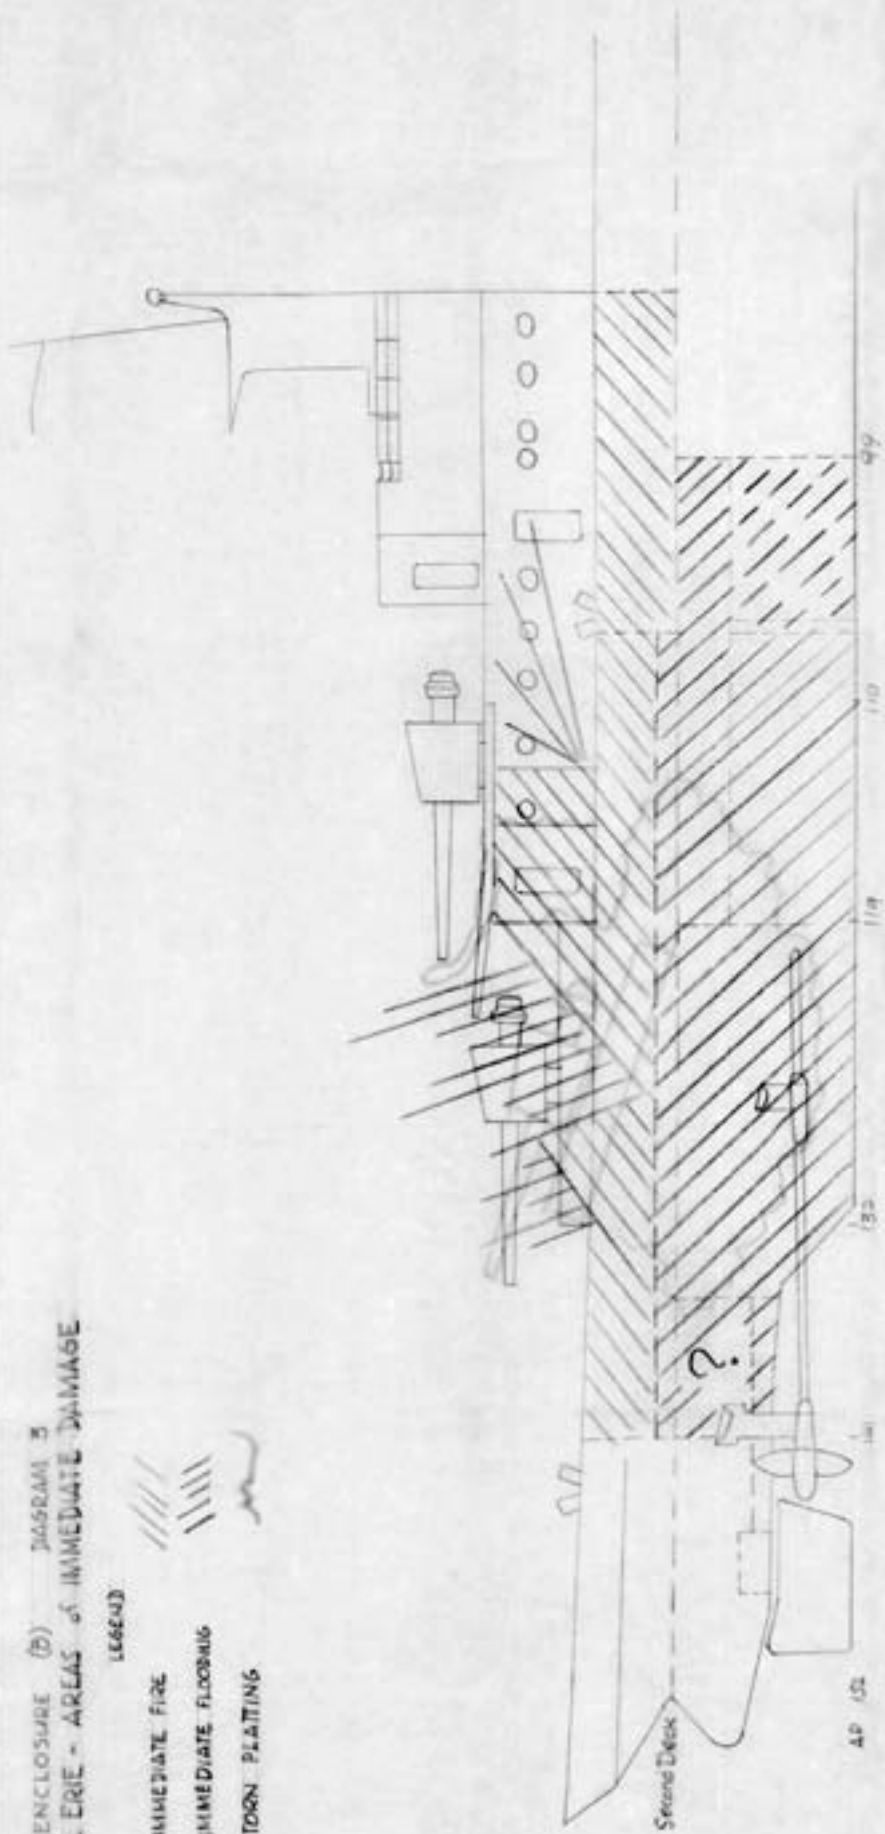
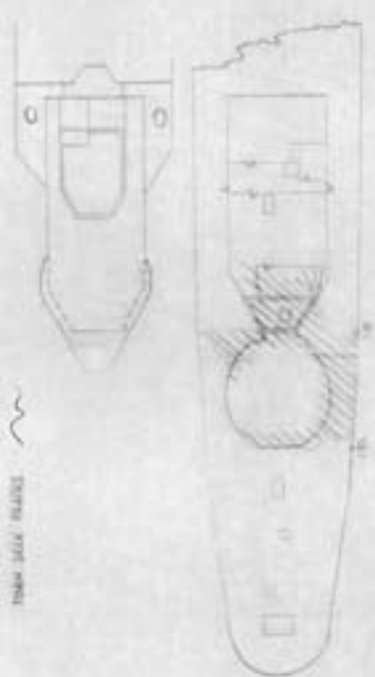
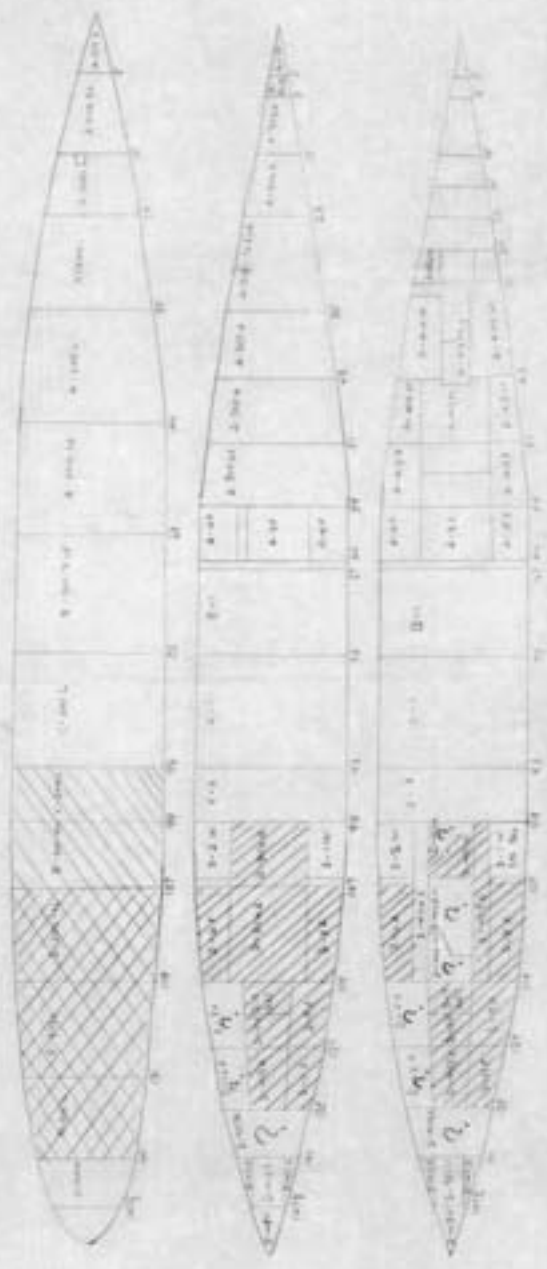
ENCLOSURE (B) DRAWING 3
USS ERIE - AREAS of IMMEDIATE DAMAGE

1. The damaged area of the hull was about centered at the point of impact of the torpedo, at frame 126, and about five feet below the water line. (See Enclosure (B), Diagrams 3 and 4.) It extended from five feet from the keel, starboard, to the main deck, and across the main deck as shown in the diagrams. Number 4 six-inch gun sagged with the explosion, and further sagging occurred later with the weakening and distortion of the supporting structure by fire. The ready service ammunition room was badly buckled, the starboard door blown off, and the port door blown open, but there was no rupture in the STS plating. The weld at the seam, between this plate and the side plating opened up in the area of the Admiral's Stateroom. The blast shield under number 3 six-inch gun was blown upward. Part of it was carried away entirely.

2. On the second deck, compartments D-202-1L, 203-L and 205-1L were practically demolished. This was the wardroom, and officers' stateroom country. Most of the partition bulkheads in this area were blown out. Bulkheads and doors 2-107 and 2-99 were warped and buckled. The compartments hatched in green pencil on Diagrams 3 and 4 were ruptured and flooded. This accounts for the great amount of fuel oil, diesel oil, and gasoline that flooded the ship in the area of the hit. Where the (?) is shown it is not known by actual sighting whether or not the compartment was flooded. Inspection was prevented due to flooded compartments above. The port shaft alley was dry upon beaching, but was flooded when inspected a few days later. It is believed that the after magazines were flooded. This could not be determined in the case of

IMMEDIATE FLOODING

TORN PLATING
