U. S. S. ERIE (PG50)

TORPEDOING AND LOSS

WILLEMSTAD, CURACAO, N. W. I.
12, NOV. - 5, DEC., 1942

WAR DAMAGE REPORT No. 31

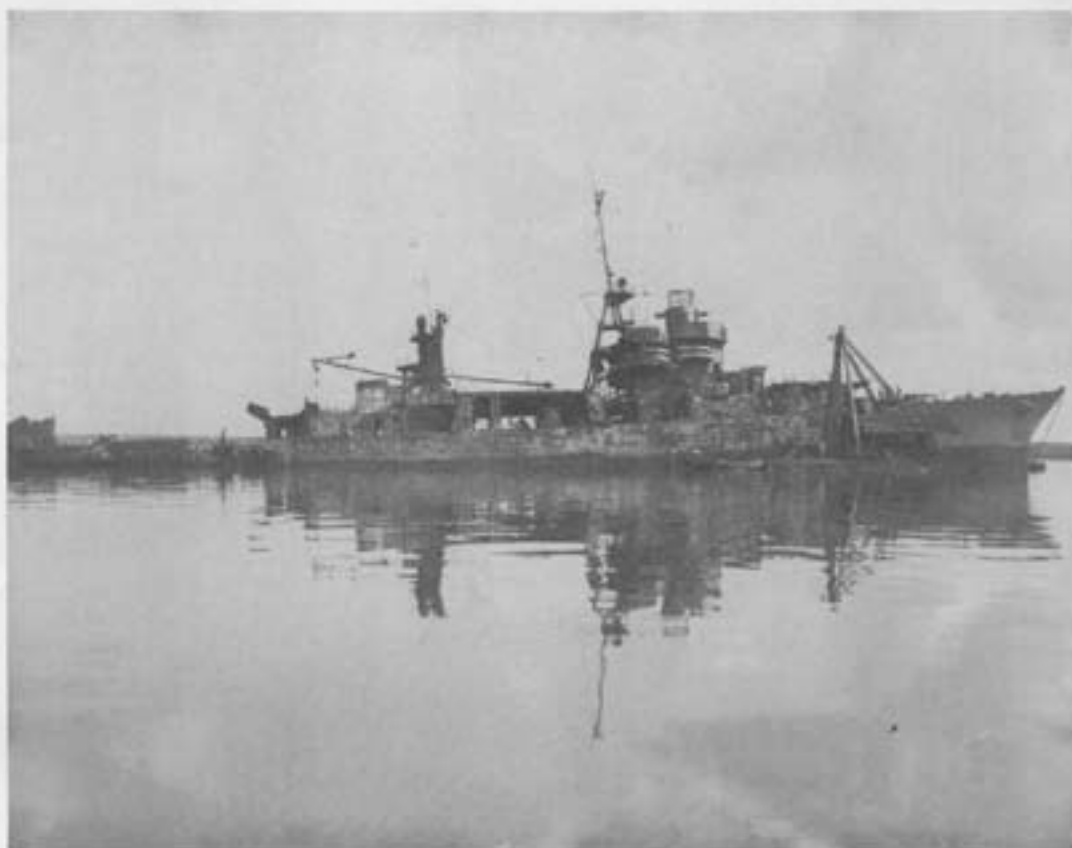
30. No change in the position of the stern section relative to the forward section was noted during the interval of 28 November to 4 December inclusive, although the stern section had been observed to be working slightly. After the hull had assumed its starboard list on the morning of 5 December, it was observed that the stern section was not in its previous position relative to the forward section. The deck line of the stern section was observed to be more nearly in alignment with the deck line of the forward section. At this point it was also observed that the Spanish windlass hung slack. As the vessel passed the upright position, when listing to port, it was observed that the stern section, still buoyant, was such as to indicate that a pronounced change of trim by the stern of the forward section had occurred. The stern section evidently remained attached to the remainder of the hull inasmuch as it too capsized.

Photo 1: USS ERIE - Willemstad Harbor, 2 December, 1942 - starboard side. Salvage operations in progress. Note sag of stern.

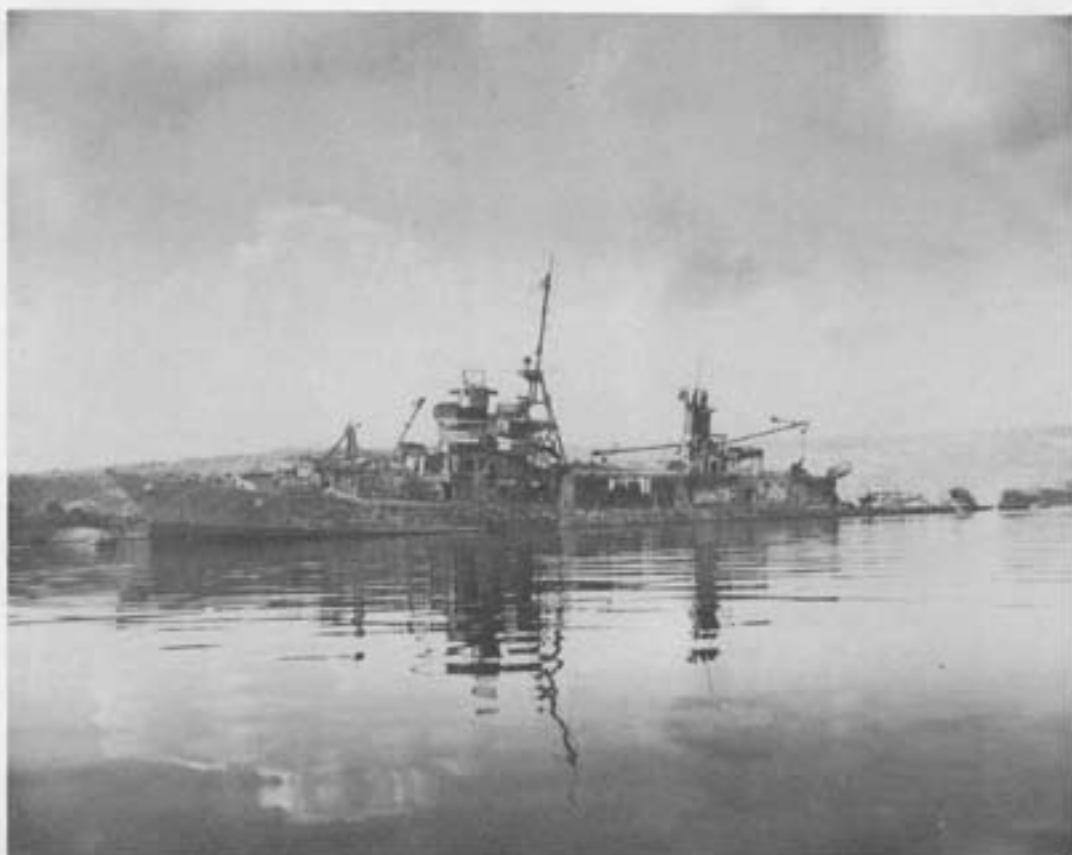
Photo 2: USS ERIE - Willemstad Harbor, 2 December, 1942 - port side.

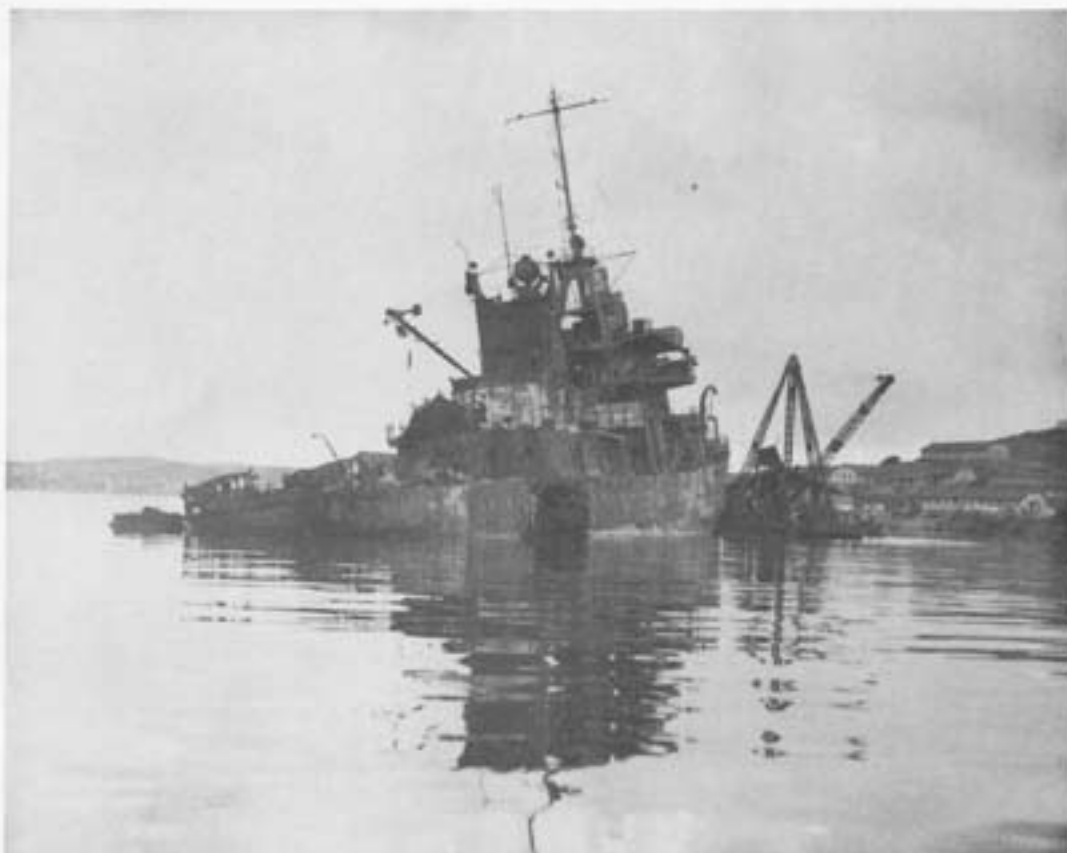
Photo 3: USS ERIE - Willemstad Harbor, 2 December, 1942 - starboard quarter.

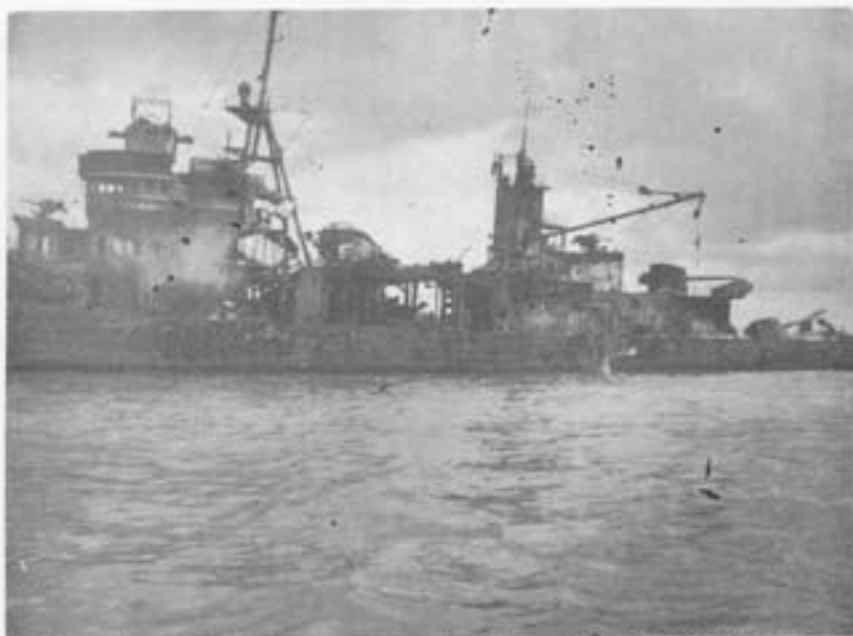
Photo 4: USS ERIE - Beached. About 18 November, 1942. Note remains of stack.

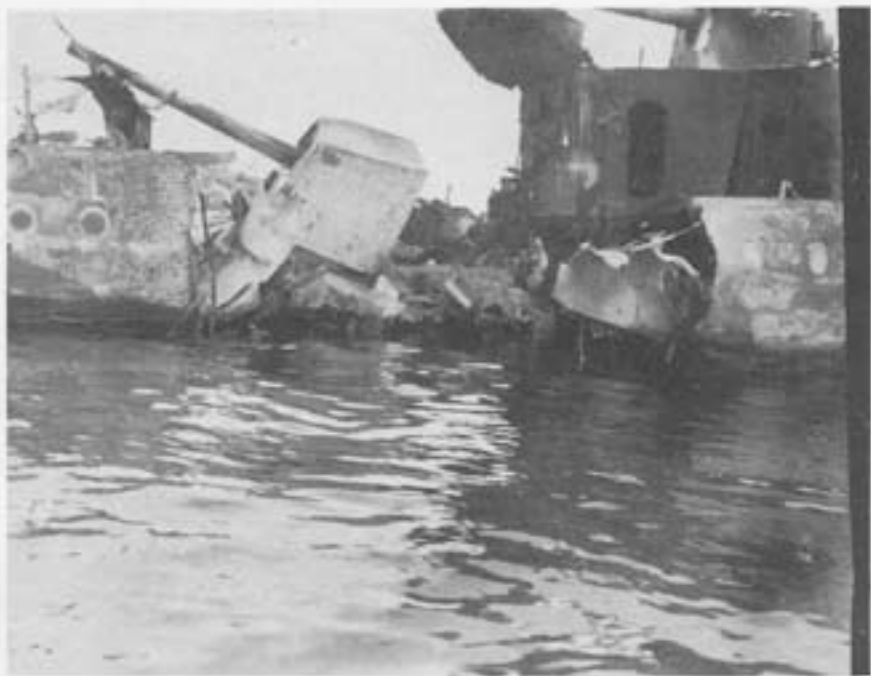
14. At 1733 ERIE was struck by a torpedo from a submerged submarine. The torpedo struck and exploded on the starboard quarter, about frame 126 (abreast the after 6" gun) and about five feet below the waterline. The hull below the waterline was ruptured for a length of about 45 feet. The break extended vertically from five feet above the keel, on the starboard side, up to the main deck and across the main deck almost to the port side. The platform and second decks were both ruptured in way of the torpedo explosion. The after 6" gun foundations were demolished and the mount fell vertically several feet. On the second deck all bulkheads between bulkheads 107 and 141 were torn and ripped. The watertight door in bulkhead 107 was distorted and could not be closed. Fuel oil tanks, the diesel oil tank and the gasoline compartment, all in way of the explosion, were largely demolished and oil and gasoline were spread throughout the second deck coincident with the flooding of the area between bulkheads 99 and 141.

32. It is known that both German and Italian submarines ordinarily use torpedoes which have a warhead charge of about 660 pounds.* The shallow depth, estimated as five feet, at which the torpedo struck the hull probably accounts for the fact that under-water damage was somewhat less than would normally be expected to result from a 660 pound explosive charge. Topside damage was comparatively more extensive than would occur from a deeper running torpedo.

Photo 5: USS ERIE - Beached. Torpedo Damage, starboard quarter.

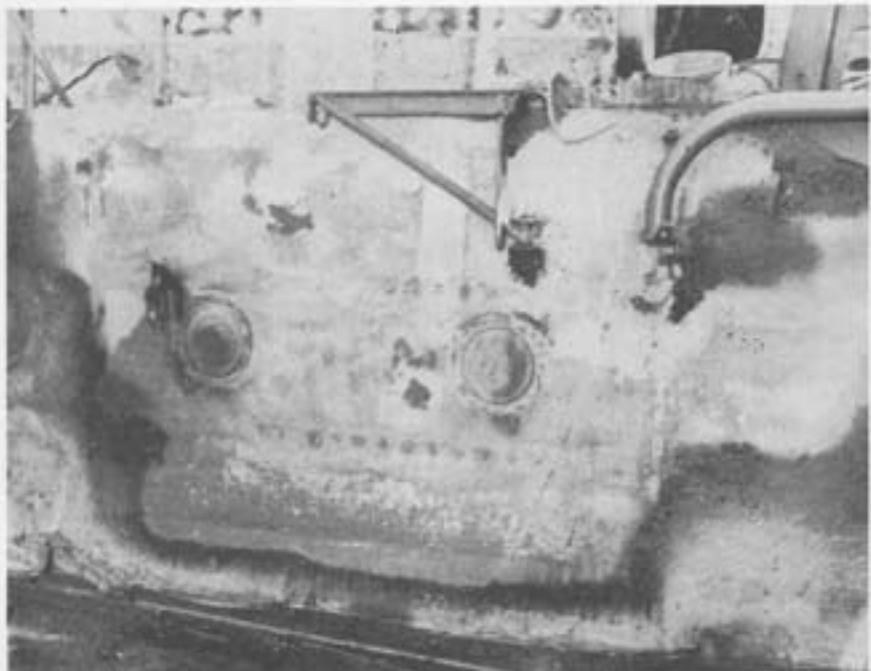
38. The fire, spreading up and forward, soon reached the vicinity of the ready service room for No. 4 6" gun. Twelve minutes after the torpedo explosion the 6" powder charges started exploding. Ten minutes later the projectiles began detonating. The heat from the fire literally roasted the ammunition. The powder charges in No. 3 ready service room were removed and placed on deck before the fire reached the stowage. After ERIE was reboarded, projectile fragment holes were found in the vicinity of all the 6" ready rooms as noted on Plate I and shown on Photos 6, 7 and 9. There was no evidence of mass explosions or detonations. This behavior of projectiles and powder charges is consistent with other battle experience and tests made by the Bureau of Ordnance.

Photo 6: USS ERIE - Port shell, frames 110-115. Note 6" projectile hole caused by projectile from No. 4 gun ready service room.

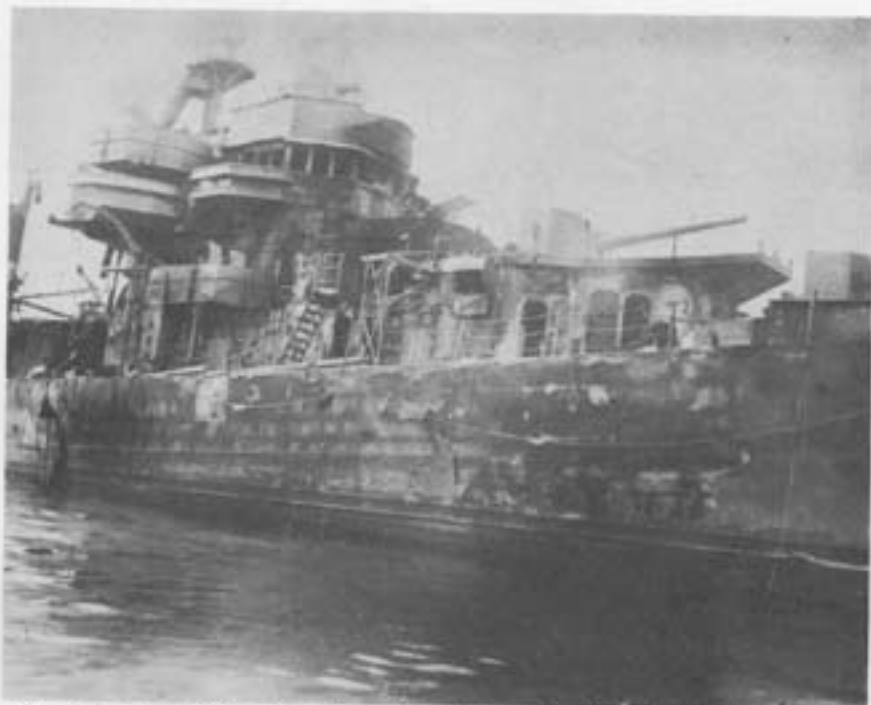
Photo 7: USS ERIE - Starboard shell, frame 15 locking aft. Note 6" projectile holes caused by projectile from No. 1 gun ready service

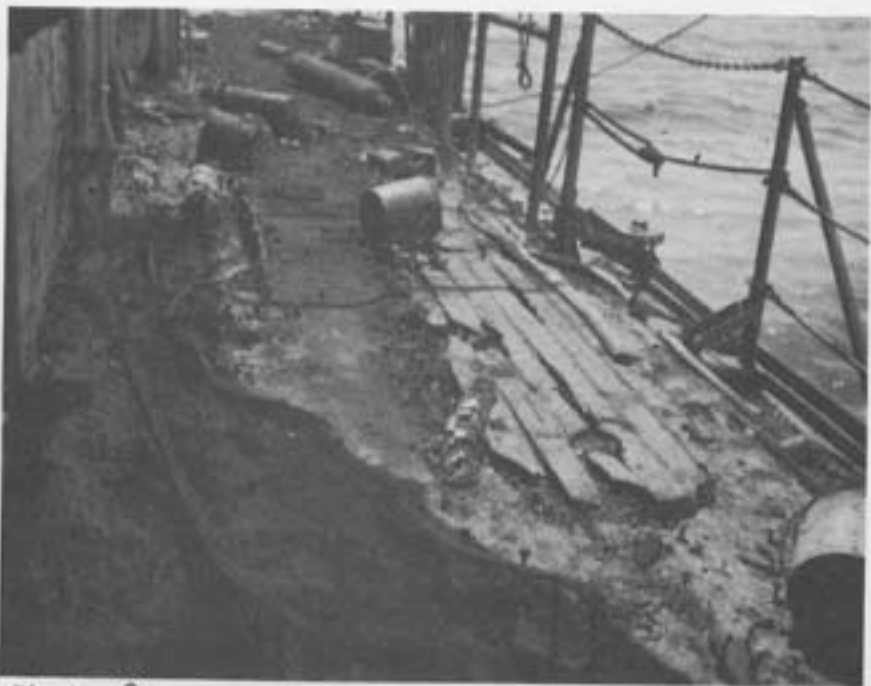
42. The Commanding Officer, in reference (a), extensively described and discussed the fire. He noted that linoleum-covered decks were badly warped, bulkheads were buckled, aluminum lockers and their contents consumed and wooden decks burned. Evidence of the intense heat generated is apparent in photos 1-3, 8 and 9. He particularly emphasized the hazard of paint on both interior and exterior surfaces. This is one of the few cases which have come to the attention of the Bureau where it is clearly evident that large quantities of paint were actually consumed by fire. Ordinarily paint is charred and blistered. Photo 8 is also the first positive evidence received that a wooden deck has been consumed by fire. Wooden decks frequently are charred, however. From all the evidence and the references, the fire which gutted ERIE appears to have been an unusually intense general conflagration to which practically everything aboard contributed.

Photo 8: USS ERIE - Main deck abreast after deck house. Note that wood deck has burned.
