STRUCTURAL REPAIRS  
IN  
FORWARD AREAS  
DURING  
WORLD WAR II

December 1949

Bureau of Ships  
Navy Department

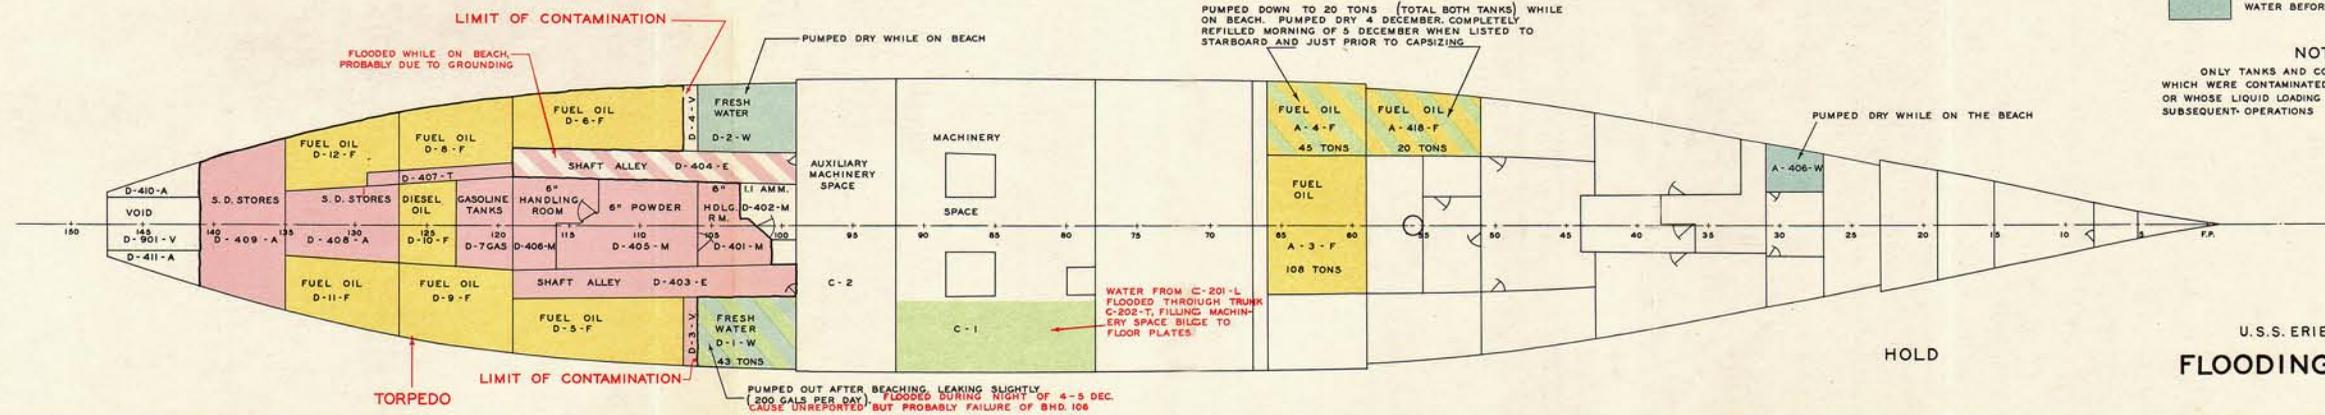
- LEGEND**
- UNCONTROLLED FLOODING DUE TO TORPEDO DAMAGE
  - FLOODING DURING MORNING OF 5 DEC. 1942
  - TANKS CONTAINING FUEL OIL BEFORE DAMAGE
  - TANKS CONTAINING FRESH WATER BEFORE DAMAGE
